Intel[®] Itanium[®] Processor

Specification Update

May 2003

Order Number: 249720-09

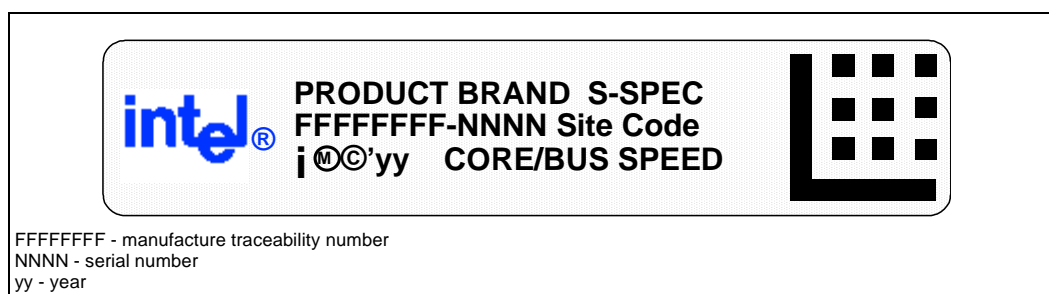
The cartridge mark for the product is a laser marked label attached to the end of the PAC418 cartridge opposite the power tab. The mark provides the following information:

- Product Brand Name
- Manufacture Traceability (including manufacturing lot and unit identification)
- Manufacturing Site
- Mask Work and Copyright Protection for the Processor and Cache Die
- Product Identification (including processor core speed, cache size, bus speed)
- Intel Company Logo
- Two-dimensional Product Identification Matrix (Intel internal use)
